## **ECO-BLOCK AUST TEST**

# **PARTY WALL ACOUSTIC ISOLATION TEST REPORT**

**Report Number:** 2107

**TEST LOCATION** 19 Beale Street Southport  
Wall system between living room and garage

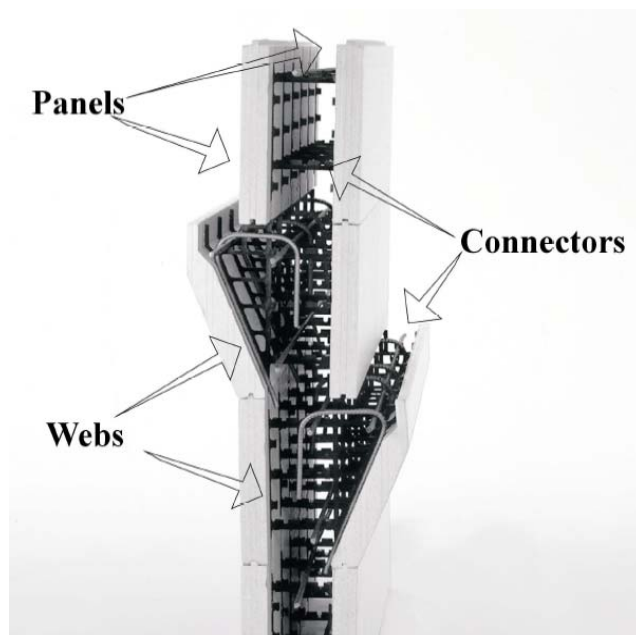
**Picture 1 : ECO Block System**

The party wall was constructed using the ECO-Block insulating concrete form system. The ECO-Block insulating concrete form system consists of foam panels, embedded with plastic studs and connectors and poured concrete. The connectors snap into the plastic studs to create complete forms, ready for stacking. By using different lengths of the connectors, and poured concrete, the wall is created. (See Picture 1) On the each side of the wall system is secured one layer of 10mm plasterboard.

The wall was a 152mm Eco Block concrete wall with 62mm of polystyrene either side. This is called the Eco Block 280 series wall (280mm).

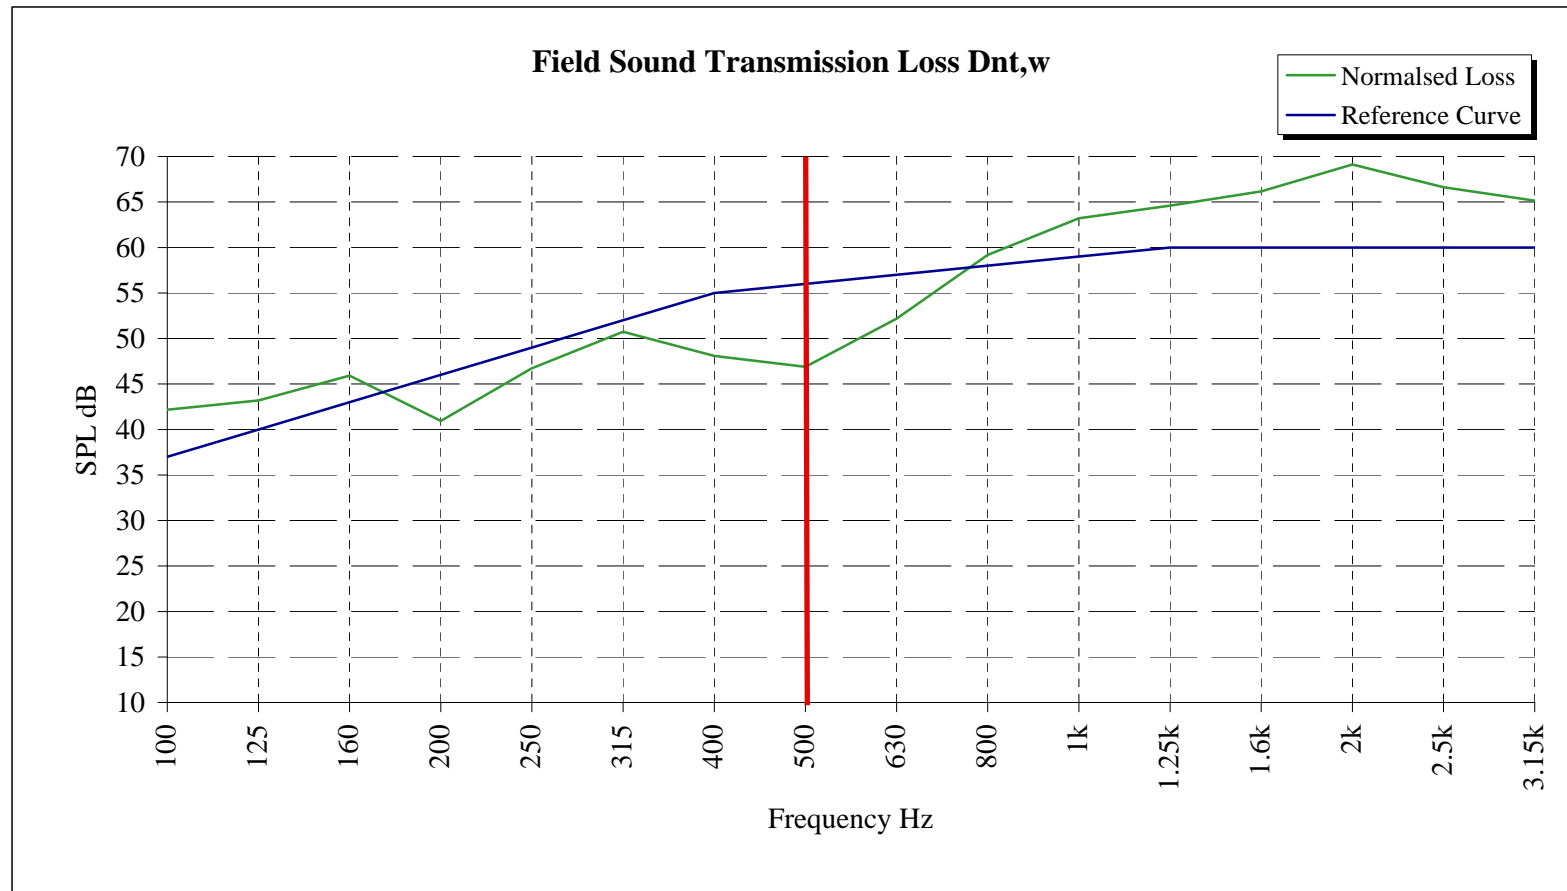
**Project :** 2107 Eco-Block Aust Test  
**Test:** Field Rw tests. Wall system (Living room to Garage) Test 2

Test Date = 8/10/2004  
 Field STC = 54 ASTM E336-90 & E413-87 (1994)  
 Dnt,w = 56 AS 1276.1:1999  
 C= -2 AS 1276.1:1999  
 Ctr= -5 AS 1276.1:1999

Test location	FSTC	Dnt,w	Ctr
Party Wall garage to living (Test 1)	54	56	-4
Party Wall living to garage (Test 2)	54	56	-5
