LOAD TEST REPORT

Customer	Eco Block PTY LTD
Customer Address	34 Gracemere St, Newmarket QLD 4051
Requested By	Tony Dal Bon
Purchase Order	-
Issuing Laboratory	MechTest - Brisbane Laboratory
Report Number	RB19-0160-02
Job Description	Pull out testing of Qty 20 screws from supplied Eco Block panel
Identification	SB19-0081-02-01 to 10 – Vertical Pull-Out (Tensile) SB19-0081-02-11 to 20 – Horizontal Pull-Out (Shear)
Material Specification	Not specified
Test Date	08 April 2019
Test Specification	Client requirements
Test Method	ASTM D1761-12
Test Technician	Shane Lyons
Test Results	Refer to Results

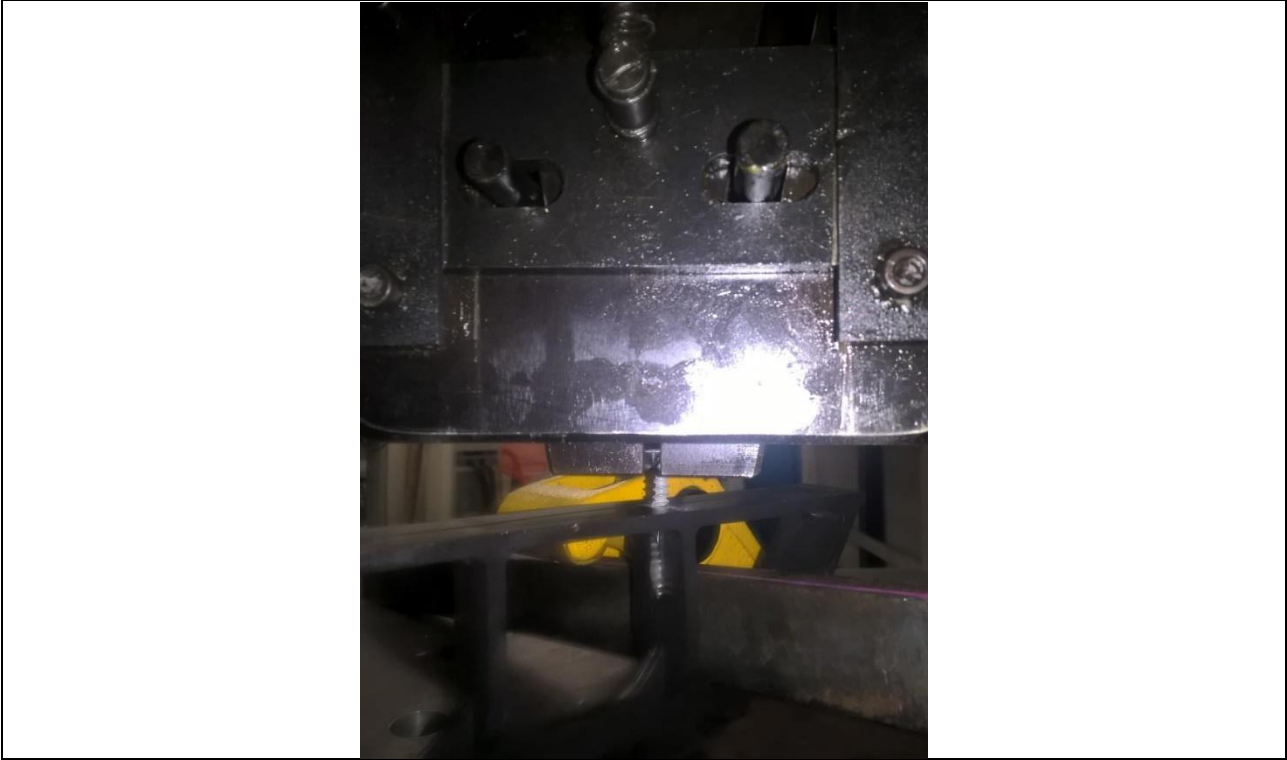
Figure 1: General photograph of Pull-Out Test (Tensile) test

Loading device	300kN UTM
Specimen details	Eco Block foam panel inserts
Load Rate	5 mm / min

Table 1 Pull-Out Test (Tensile) Results

Sample ID	Max. Withdrawal Load [kN]	Max. Withdrawal Load [kg]	Max. Withdrawal Load [lbs]	Comments
01	1.32	135	297	Tested at the Rib
02	1.14	116	256	Tested away from the Rib
03	1.08	110	243	Tested away from the Rib
04	1.14	116	256	Tested at the Rib
05	1.14	116	256	Tested away from the Rib
06	1.08	110	243	Tested away from the Rib
07	1.08	110	243	Tested at the Rib
08	1.14	116	256	Tested at the Rib
09	1.08	110	243	Tested away from the Rib
10	1.26	128	283	Tested at the Rib
Average	1.15	117	258	-
St. Dev.	0.08	7.95	17.5	-

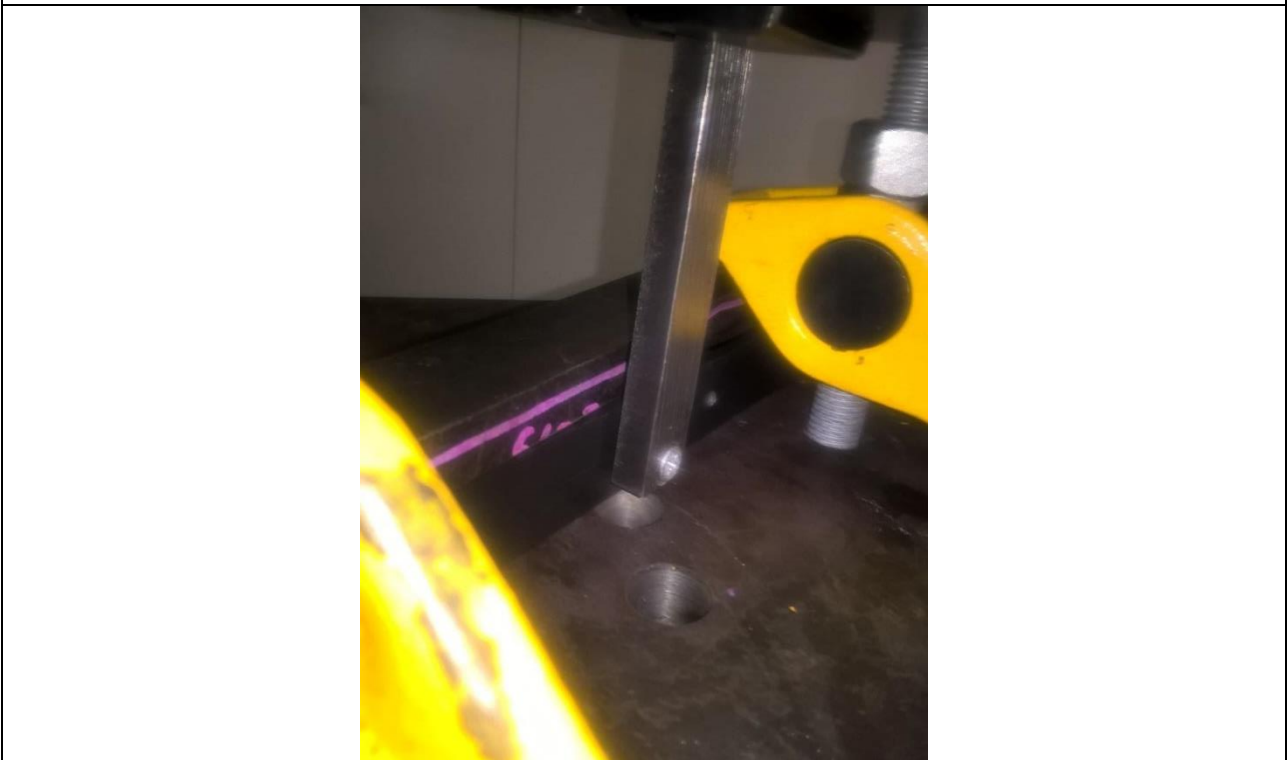
Figure 2: General photograph of Pull-Out Test (Shear) test

Table 2 Pull-Out Test (Shear) Results

Sample ID	Max. Lateral Load [kN]	Max. Lateral Load [kg]	Max. Lateral Load [lbs]	Comments
11	1.5	153	337	Tested at the Rib
12	1.98	202	445	Tested away from the Rib
13	1.74	177	391	Tested away from the Rib
14	1.68	171	378	Tested at the Rib
15	1.14	116	256	Tested away from the Rib
16	1.14	116	256	Tested away from the Rib
17	1.26	128	283	Tested away from the Rib
18	1.32	135	297	Tested at the Rib
19	1.38	141	310	Tested away from the Rib
20	1.56	159	351	Tested at the Rib
Average	1.47	150	330	-
St. Dev.	0.26	26.56	58.6	-
